**Flood Control Project Maintenance
Levee Inspections**
LMA District Cover Sheet
Spring 2017 Levee Inspection Results

Reclamation District No. 0349 Sutter Island

Spring 2017 Levee Inspection Results

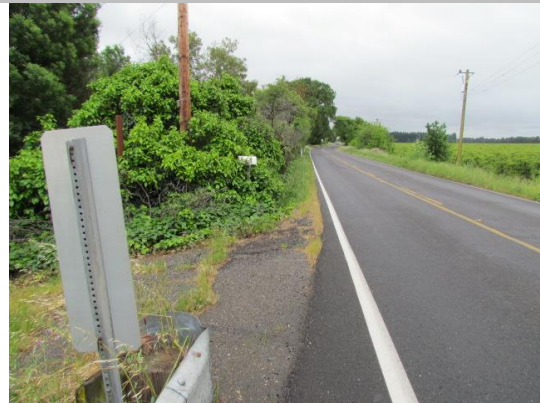
Photo 1 of 1 : SP_2017_RD0349_204_20_20170426_00025.jpg

RD 349 Unit 1 Levee mile 0.01 waterside shoulder looking downstream.

LM Start	0.03	Rating **	M	Issue No.	7
LM End	0.10	Issue Type +	Ma	Location *	WS
Category	Supplemental			GPS Latitude/Longitude	
				Start	End
Item	2015 USACE Erosion Survey, DRAFT			38.326743 °	38.325844 °
				-121.576979 °	-121.577119 °
DWR ID	DWR_RD0349_01_s_2016_7				
Comment Code					
Inspector Comment					
2015: Erosion observed at the toe. [2015 Site ID: SAC_33-9_R]

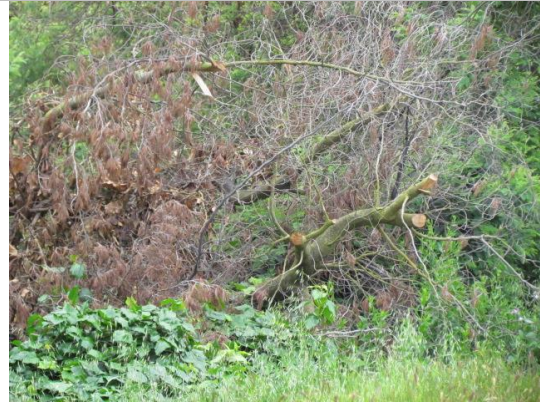
Photo 1 of 1 : SP_2017_RD0349_204_11_20170516_00026.jpg

Waterside slope fallen dead tree branches cut up and remains on the levee slope.

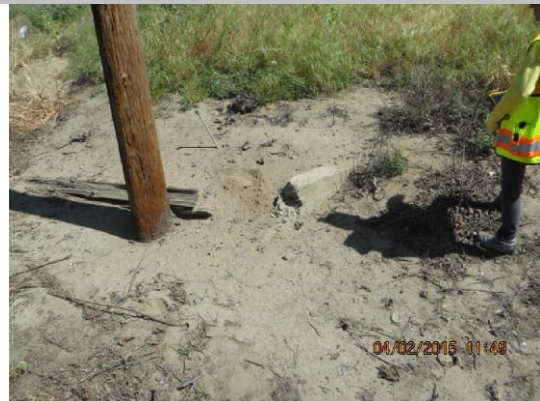
Photo 1 of 3 : UCIP_SP_2017_44303_73622.jpg

LM Start	0.08	Rating **	M	Issue No.	22
LM End	0.08	Issue Type +	En	Location *	WS
Category	Supplemental			GPS Latitude/Longitude	
				Start	End
Item	DWR UCIP Field Study			38.326133 °	38.326133 °
				-121.577141 °	-121.577141 °
DWR ID					
Comment Code					
Inspector Comment					
FS_ID:44303 DS_ID:24137 EP_NO: N/A Repair Type: Non-Urgent Crossing Status: Indicator Found UCIP Comments: Pipe appears to be abandoned and if so should be done so properly. Electromagnetic survey indicated a crossing at this location. FIELD_STRUCT_DESC: *ABANDONED* 10-inch pipe through the levee, 3.8 feet below the crown. Power pole and anchor on the landward side. Deteriorated concrete box at the LS toe. Concrete debris on WS toe good indicator of pump location (USACE-1960). This entry matches the Drainage or Irrigation Structure referenced in O&M manual (HLM 2.74). FS Date: 4/2/2015

Deteriorated concrete distribution box on LS toe next to power pole.

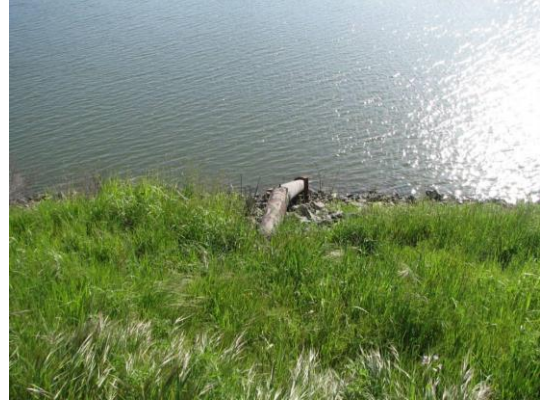
Photo 1 of 3 : UCIP_SP_2017_50062_36547.jpg

Comment Code					
Inspector Comment					
FS_ID:50062 DS_ID:24139 EP_NO: 951 Repair Type: Non-Urgent Crossing Status: Found UCIP Comments: 8/22/2016 Meet Fred Wheeler with RD349 at this crossing. Crossing is active. Crossing was downgraded from Urgent to Non-Urgent -- no signs of pipe failure visible on surface. Need to contact owner -- dense vegetation on WS and LS should be cleared prior to next inspection. Need to coordinate with owner regarding the 8-inch sleeved pipe--need permit number to update record. (DWR UCIP - omagana)3/18/2009 Exposed section of levee slope on LS--need to contact owner and DWR inspector. Burrow activity noticed at crossing 10 inch holes. Dense vegetation limits the inspector's visibility to identify signs of pipe failure (leaks) along the slope. Recommend removing vegetation along pipe alignment to conduct proper inspection of structure and appurtenances. Note date on photos should be 3/18/09 not 7/26/08 camera metadata is incorrect. (DWR UCIP - omagana) FIELD_STRUCT_DESC: 8-inch steel pipe measured (instead of 10-inch) sleeved through a 12-inch steel pipe, 6.6 feet below the crown. Annular gap grouted at both ends. Active centrifugal pump on platform at landside (LS) toe. Inactive slant pump on steel platform on waterside slope (not present in 2008 referenced in USACE O&M manual). Exposed section pipe on WS slope. Service pole on the LS slope. (10-inch pipe sleeved through pre-existing 12-pipe under Permit No. 3382, 1960 - Davis J. Eliot and Son; 12-inch pipe authorized in under Permit No. 951, 1944 - Stillwater Orgards Company). [Additional Reference(s): DWR Levee Log, 2005. USACE San Joaquin O&M Manual Unit No. 110, May 1959, (HLM 0.5)]. FS Date: 8/17/2016

View of pipe on WS with rip rap on toe--dense vegetation on slope.

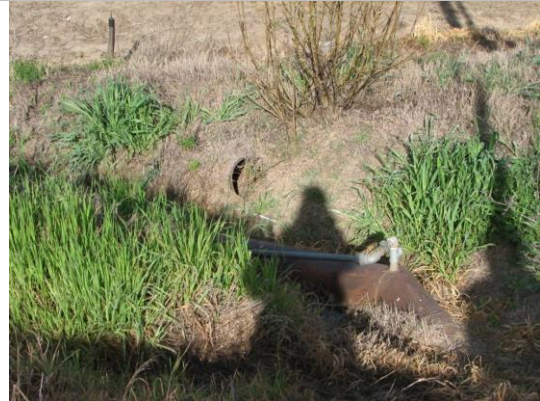
Photo 2 of 3 : UCIP_SP_2017_50062_36546.jpg

View of pipe on LS--open cut section.

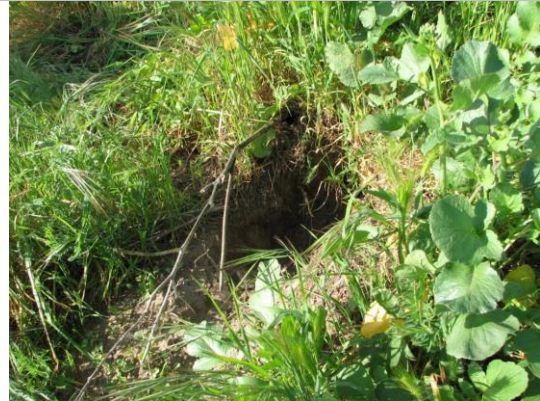
Photo 3 of 3 : UCIP_SP_2017_50062_36548.jpg

Dense burrow activity--10 inch hole present.

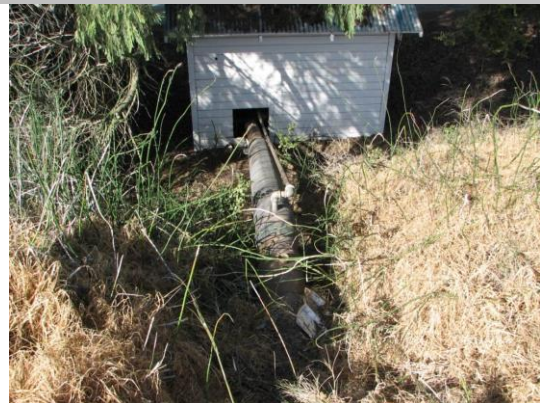
Photo 2 of 3 : UCIP_SP_2017_50013_36558.jpg

View of LS slope--open cut.

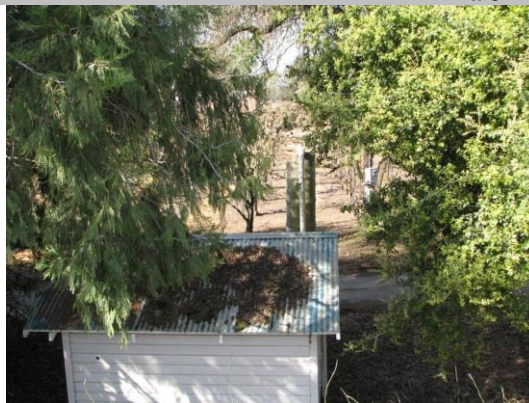
Photo 3 of 3 : UCIP_SP_2017_50013_36556.jpg

View of LS: pump house, concrete stand pipe, and electric pole.

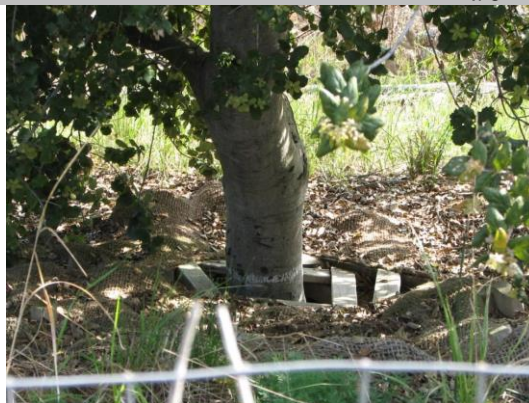
Photo 1 of 3 : UCIP_SP_2017_44304_36580.jpg

Comment Code					
Inspector Comment					
FS_ID:44304					
DS_ID:24141					
EP_NO: N/A					
Repair Type: Non-Urgent					
Crossing Status: Found					
UCIP Comments: 2007 DWR erosion repair site location?--need to find out fate of crossing. Dense vegetation limits the inspector's visibility to identify signs of pipe failure (leaks) along the slope. Recommend removing vegetation along pipe alignment to conduct proper inspection of structure and appurtenances. Note date on photos should be 3/18/09 not 7/26/08 camera metadata is incorrect.					
FIELD_STRUCT_DESC: *ABANDONED* Pumphouse at landward toe. Pressure breaker on landward side. Electromagnetic Survey indicated a crossing at this location as well.					
FS Date: 4/2/2015

Geotech fabric and protective frame at tree--design features of erosion repair site 2007-2009.

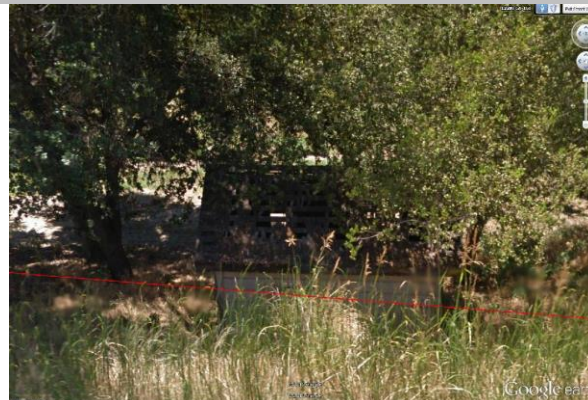
Photo 2 of 3 : UCIP_SP_2017_44304_73625.jpg

Pumphouse on LS toe (From google view)

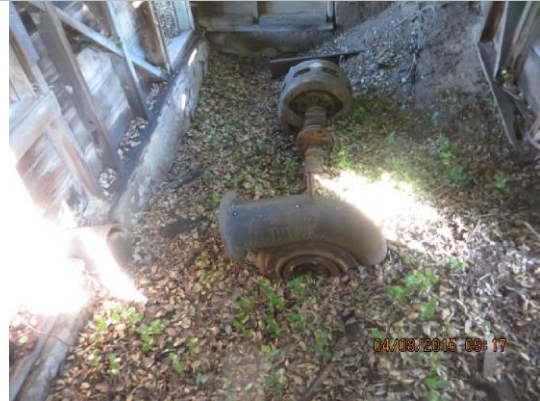
Photo 3 of 3 : UCIP_SP_2017_44304_73680.jpg

Pump and motor inside pumphouse at LS toe. No pipe visible.

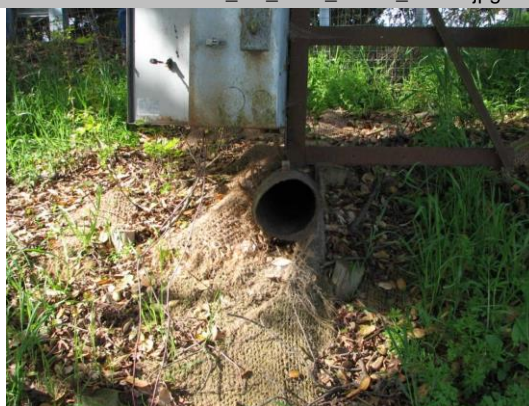
Photo 3 of 3 : UCIP_SP_2017_44214_36570.jpg

View of pipe at waterward shoulder with control box.

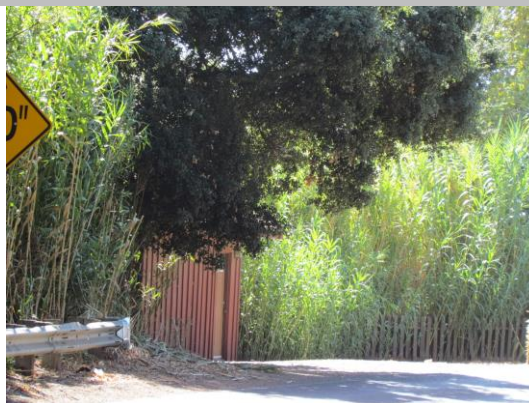
Photo 1 of 1 : SP_2017_RD0349_204_13_20170404_00002.jpg

RD 349 Unit 1 waterside shoulder and slope levee mile 1.56-1.58.

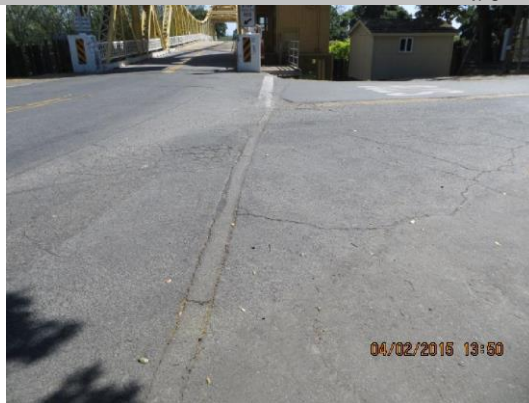
Photo 1 of 3 : UCIP_SP_2017_46168_74542.jpg

LM Start	0.00	Rating **	M	Issue No.	86
LM End	0.00	Issue Type +	En	Location *	LS
Category	Supplemental			GPS Latitude/Longitude	
				Start	End
Item	DWR UCIP Field Study			38.305124 °	38.305124 °
				-121.574772 °	-121.574772 °
DWR ID					
Comment Code					
Inspector Comment					
FS_ID:46168 DS_ID:25096 EP_NO: N/A Repair Type: Non-Urgent Crossing Status: Indicator Found UCIP Comments: Need to identify permit for crossing. FIELD_STRUCT_DESC: 2-inch waterline through the levee at an unknown depth below crown. Pipe provides service to bridge and beach (per landowner). FS Date: 4/9/2015

Cut in pavement good indicator of pipe location.

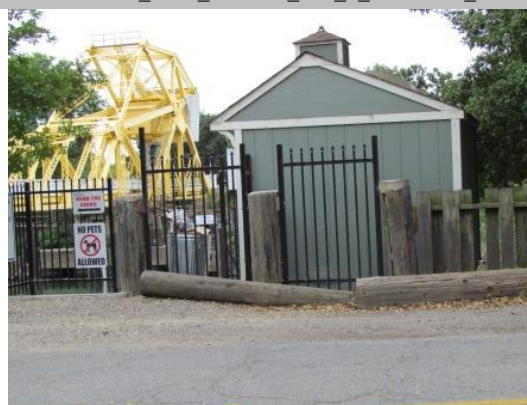
Photo 1 of 2 : SP_2017_RD0349_205_4_20170404_00006.jpg

Unauthorized building waterside shoulder; Unit 2 Sutter Slough.

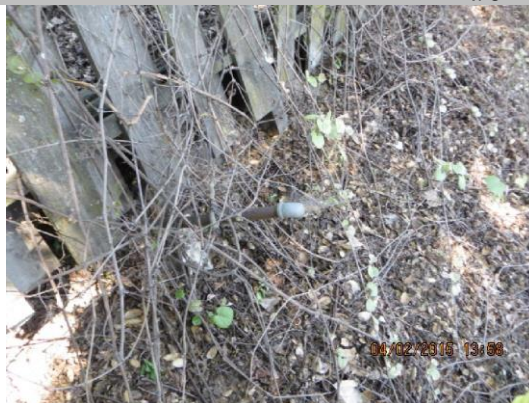
Photo 1 of 3 : UCIP_SP_2017_46169_74545.jpg

LM Start	0.04	Rating **	M	Issue No.	87
LM End	0.04	Issue Type +	En	Location *	WS
Category	Supplemental			GPS Latitude/Longitude	
				Start	End
Item	DWR UCIP Field Study			38.304885 °	38.304885 °
				-121.575369 °	-121.575369 °
DWR ID					
Comment Code					
Inspector Comment					
FS_ID:46169 DS_ID:25098 EP_NO: N/A Repair Type: Non-Urgent Crossing Status: Found UCIP Comments: Appears abandoned and if so should be done so properly. Need to identify permit. FIELD_STRUCT_DESC: 1-inch waterline through the levee 1.5-feet below the crown. Pipe visible at fence on WS slope. FS Date: 4/9/2015

Pipe visible at base of fence on WS shoulder.

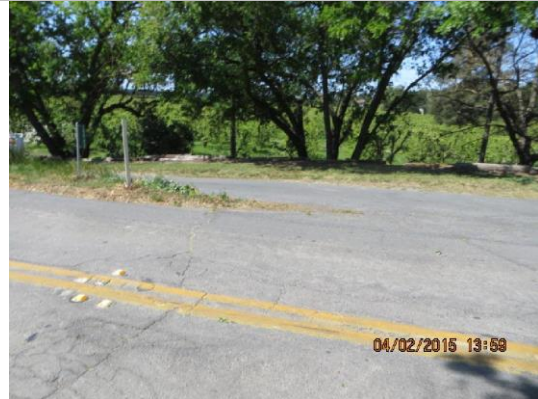
Photo 3 of 3 : UCIP_SP_2017_46169_74547.jpg

Approximate location of pipe alignment on LS of crown.

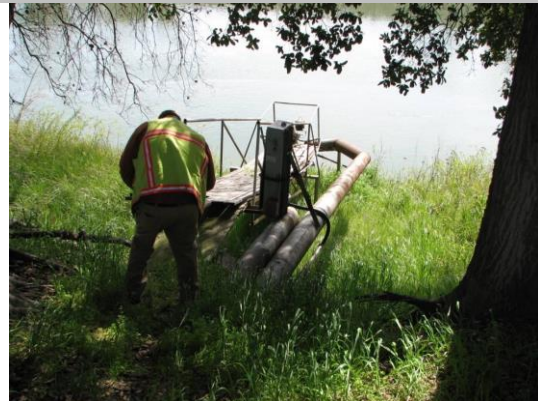
Photo 1 of 3 : UCIP_SP_2017_21576_36593.jpg

Dense vegetation on waterward slope--2 pipes and 1 conduit.

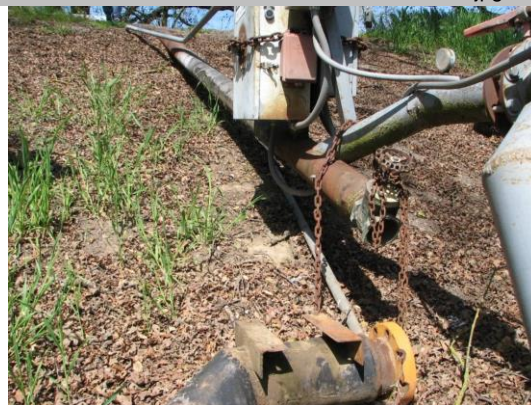
Photo 2 of 3 : UCIP_SP_2017_21614_36690.jpg

Crossing has been altered--abandoned pipe through levee slope remains.

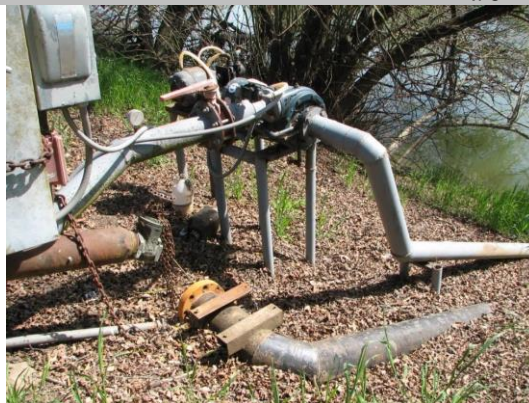
Photo 3 of 3 : UCIP_SP_2017_21614_36689.jpg

New configuration--sections of pipe have been abandoned.

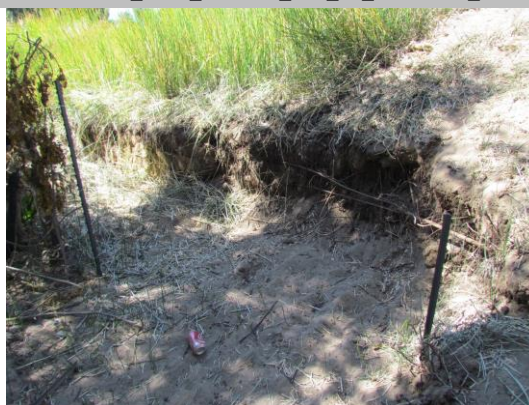
Photo 1 of 2 : SP_2017_RD0349_205_36_20170404_00016.jpg

RD 349 Unit 2 waterside slope and berm Land owner has dug a pit.

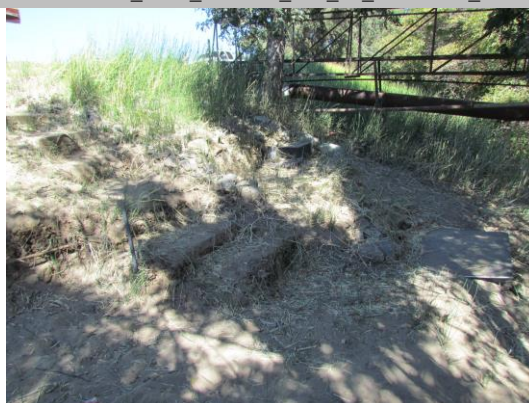
Photo 2 of 2 : SP_2017_RD0349_205_36_20170404_00018.jpg

LM Start	1.08	Rating **	U	Issue No.	36 (cont)
LM End	1.08	Issue Type +	Ma	Location *	WS

The landowner has knotted step into the waterside slope.

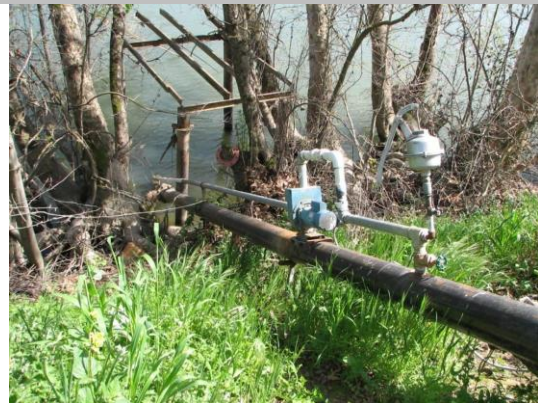
Photo 1 of 3 : UCIP_SP_2017_21606_36655.jpg

View of abandoned framing located on river's edge.

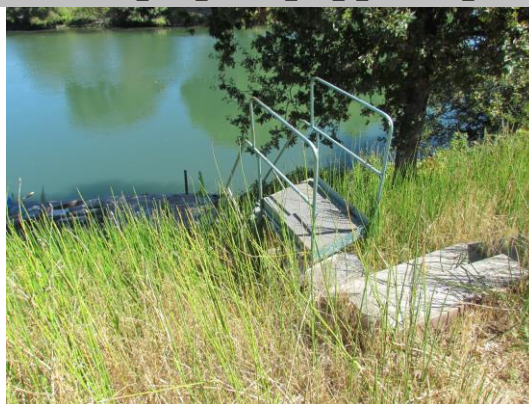
Photo 1 of 3 : SP_2017_RD0349_205_1_20170404_00001.jpg

Unauthorized metal steps on the waterside levee slope at levee mile 2.39.

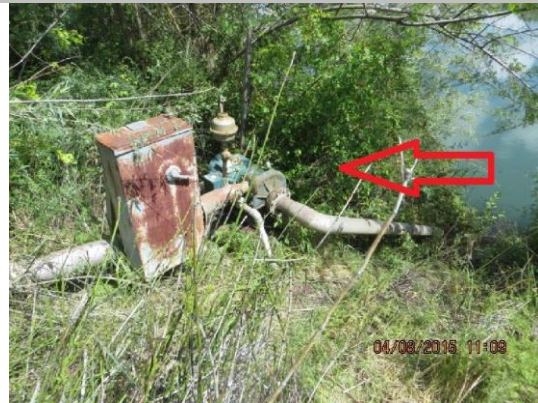
Photo 1 of 3 : UCIP_SP_2017_50015_73709.jpg

Abandoned pipe visible on slope in vegetation behind new pipe on WS slope.

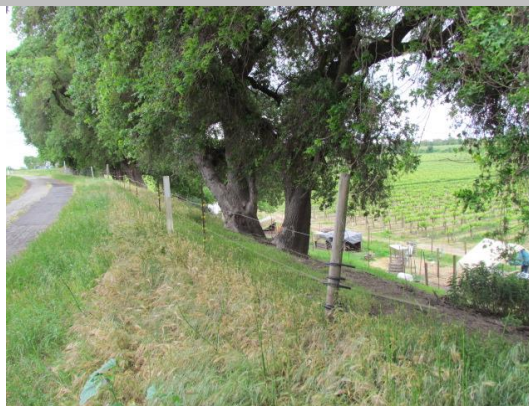
Photo 1 of 1 : SP_2017_RD0349_205_59_20170516_00092.jpg

Unauthorized electric fence installed along the shoulder and levee slope landside .

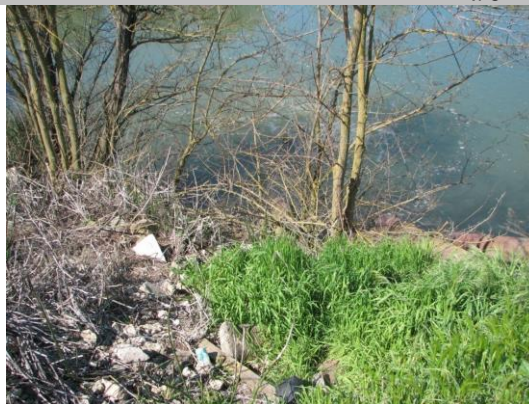
Photo 3 of 3 : UCIP_SP_2017_21632_36734.jpg

All 3 pipes visible on waterward side--tall grass limits inspection on waterward side.
